REPORT OF FIELD STUDIES ON THE WILLAPA RIVER  
August 29-31, 1972 and September 19-20, 1972

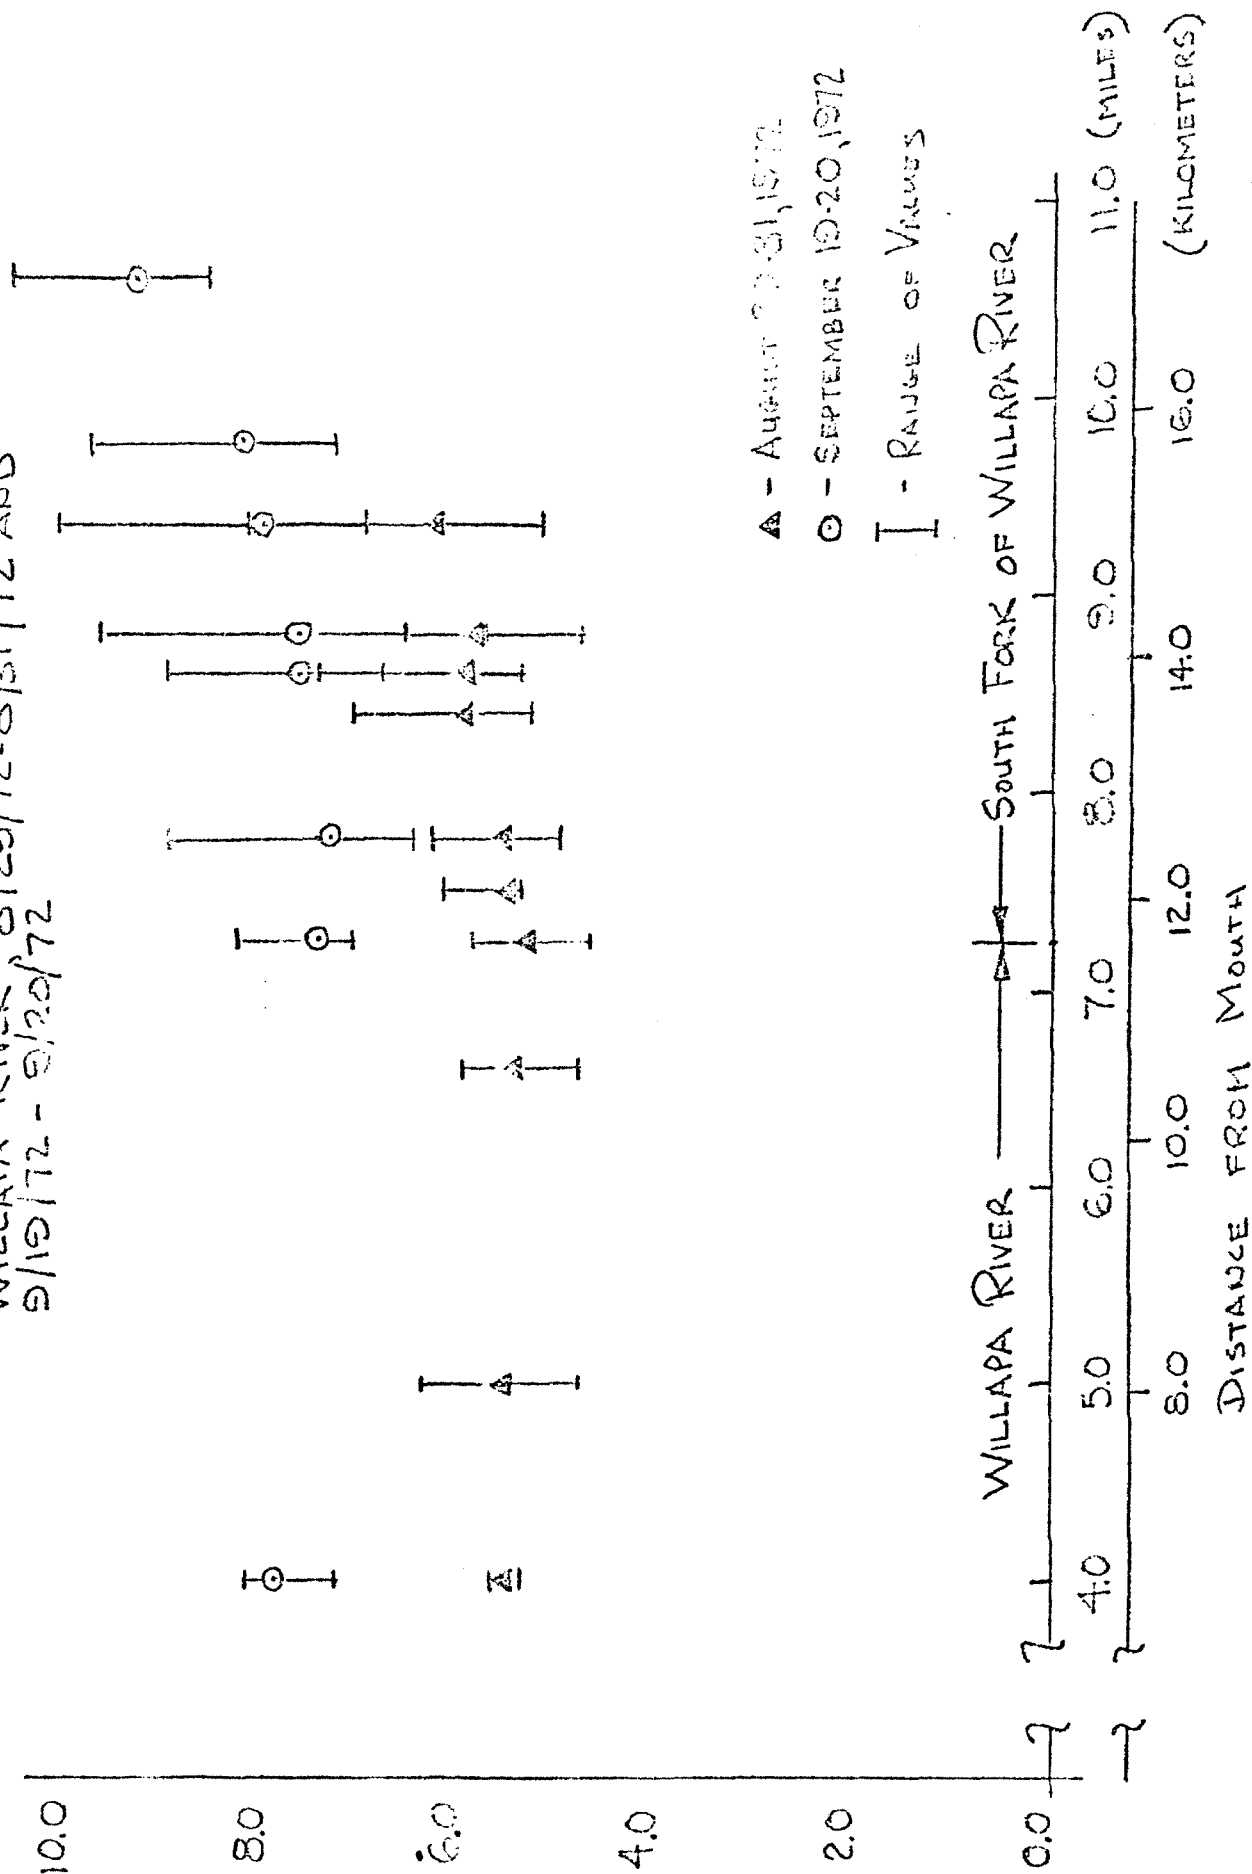
FIGURE 6. AVERAGE DISSOLVED OXYGEN IN THE  
WILLAPA RIVER, 8/29/72-8/31/72 AND  
9/19/72-9/20/72

Average dissolved oxygen during each of the surveys are plotted in Figure 6. At individual stations the average dissolved oxygen values during the September 19-20 survey were from 1.7 to 2.2 mg/l greater than corresponding values from the August 29-31 survey. In addition, the ratio of the instream dissolved oxygen to the saturation value of dissolved oxygen (percent saturation) (Figure 1) increased between 10% and 20% from August 29-31 and September 19-20. Dissolved oxygen deficit (Figure 8) decreased between 0.8 mg/l and 1.4 mg/l.

During the August 29-31 sampling period, dissolved oxygen values below the marine waters standard of 6.0 mg/l were measured throughout the sample area. Table 3 shows the ratio of water quality criterion violations to number of samples taken. The ratio increases downstream. On the South Fork the ratio doubles between the primary treatment plant outfall and the confluence of the main stem and the South Fork.
